Case Study: “Value-Engineered” Waterproofing Errors

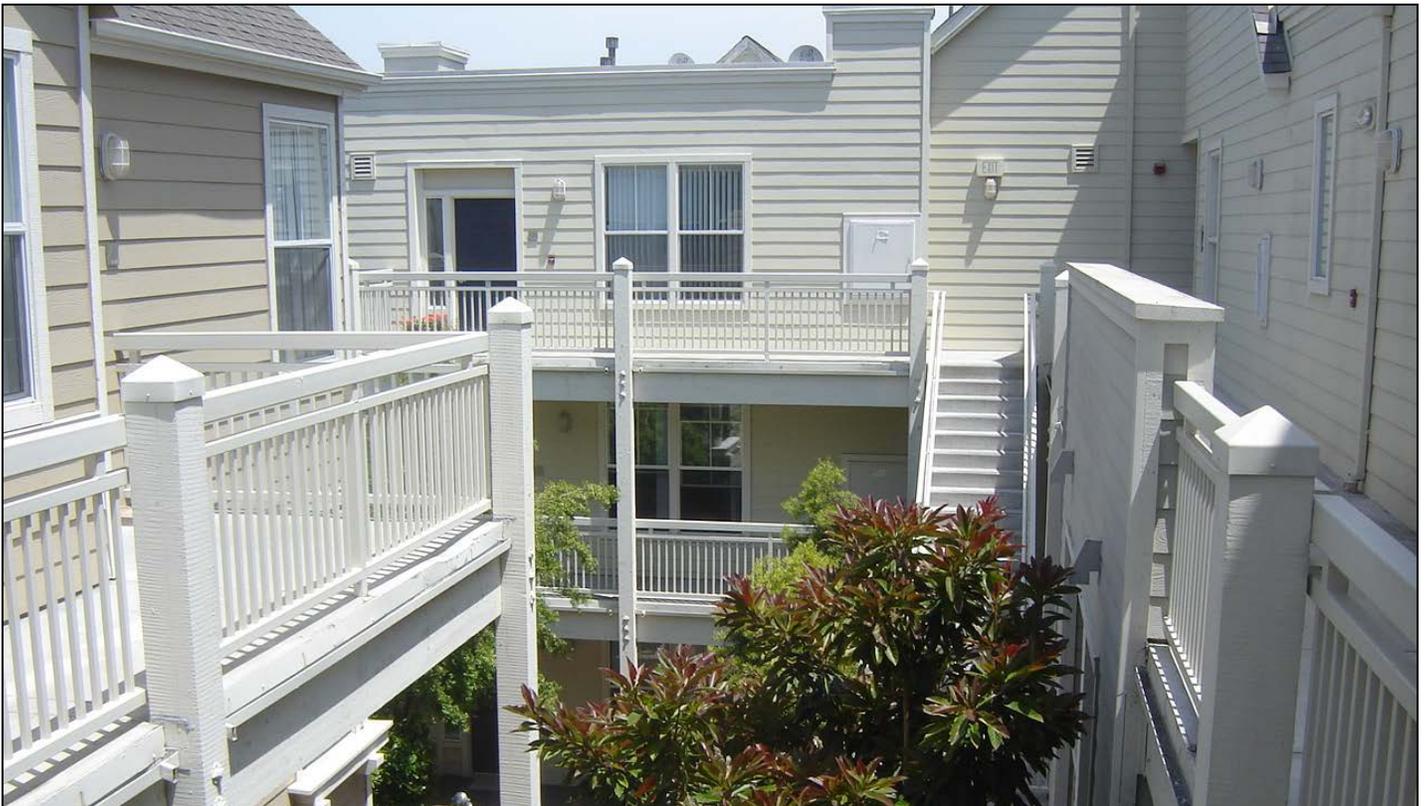
Figure 1 – Upper-story tenants at this apartment complex are served by 3,000 lineal feet of wood-framed elevated walkways.

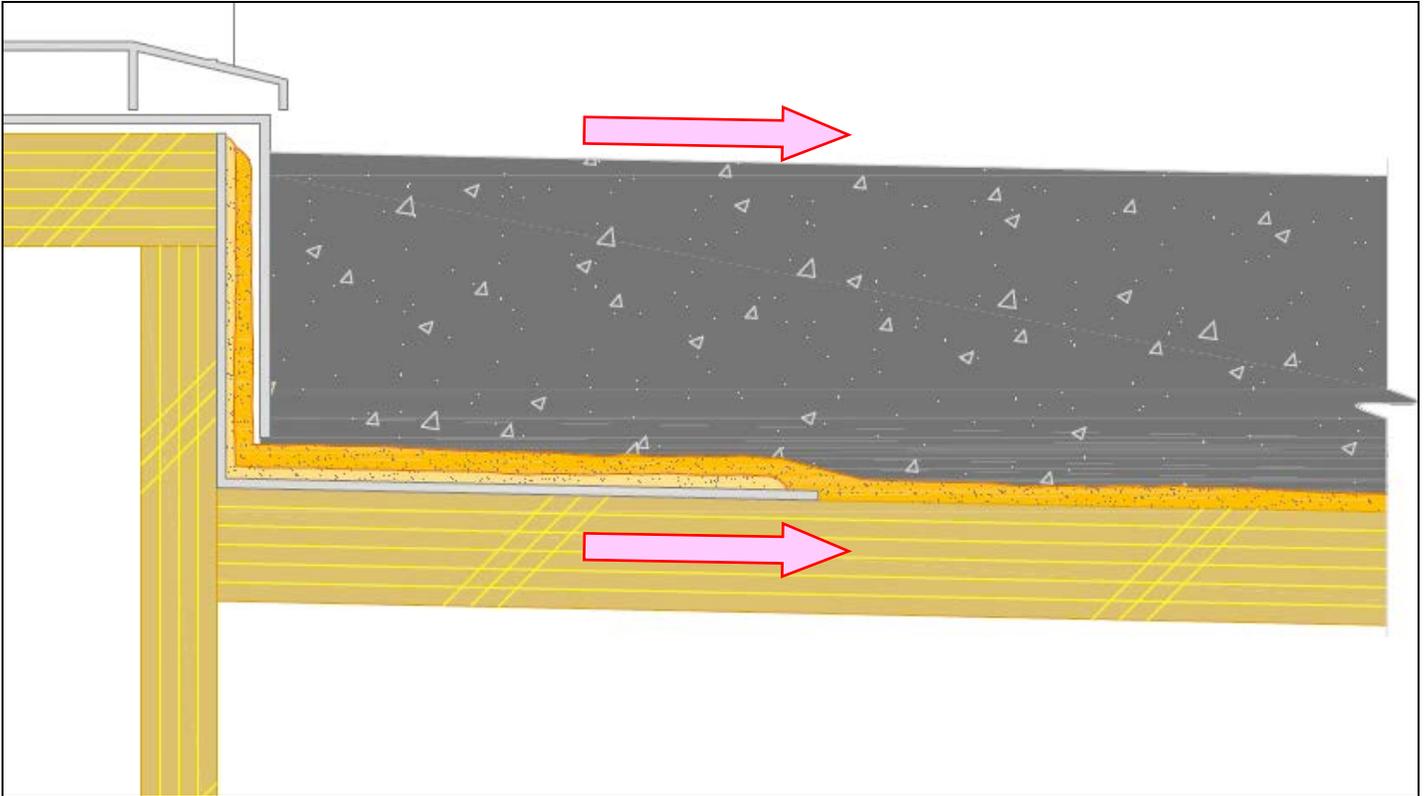
Figure 2 – The architect’s original design called for positively sloped framing, decking, waterproofing, and concrete that served to drain rainwater toward the exterior edges of these elevated walkways. (Litigation exhibit by Andrew D. Trias.)

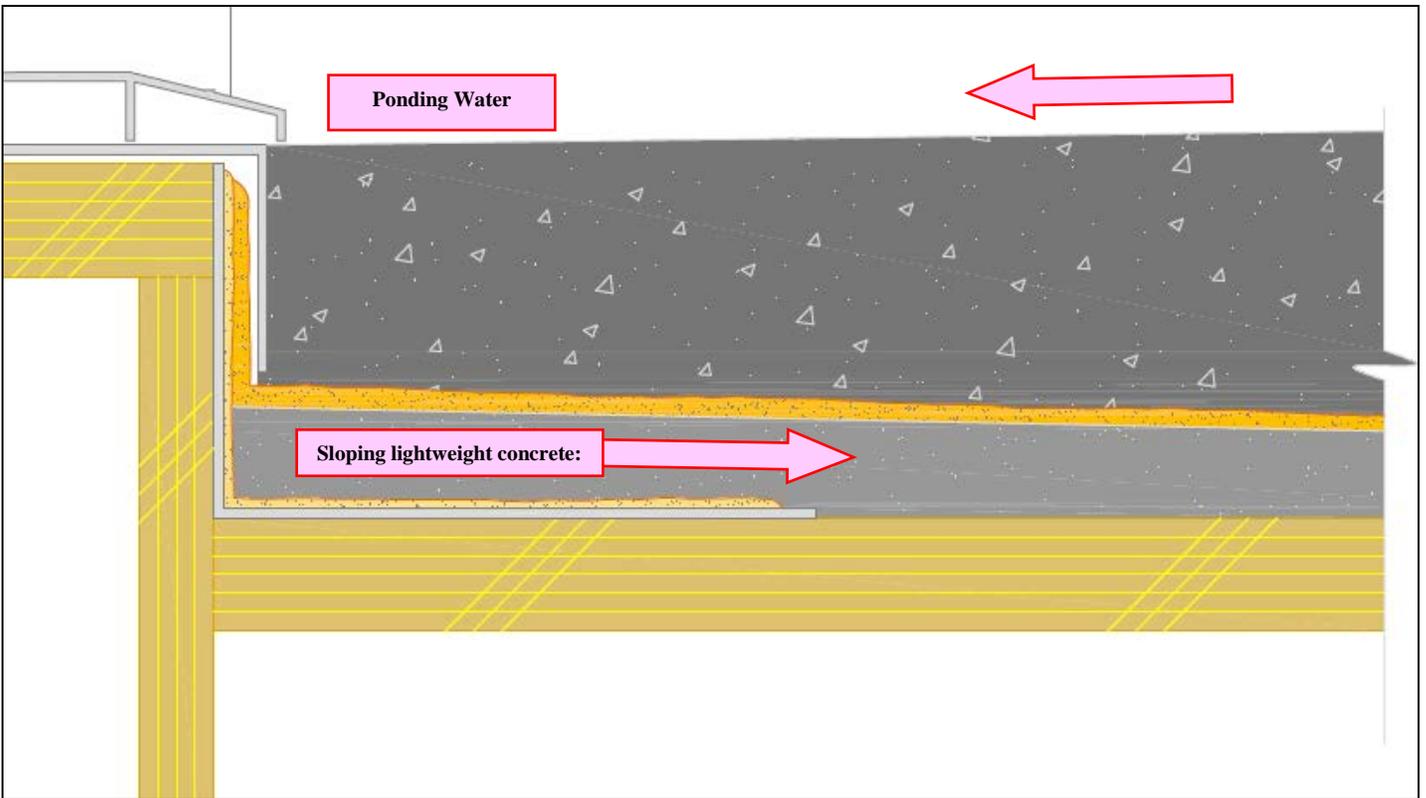
Figure 3 – The as-built proposal instead provided sloping lightweight concrete under the waterproofing membrane. However, this alternate design produced negative slope, ponding water, and locally severe framing damage below the concrete walking pad. (Litigation exhibit by Andrew D. Trias.)

Unfortunately, during the entire course of construction, both the architect and the contractor failed to recognize that due to: a) the additional thickness of the lightweight concrete and b) the additional height that was inherent in *not tapering* the wood framing per the original plans, the outside elevations of these concrete walkways were being raised significantly in relation to the already-fixed height of the apartment entry doors (compare Figures 3 and 4.)

By not taking into account the predetermined elevations of these door thresholds, the architect and contractor allowed the as-built walkways to be negatively sloped toward many of these entry doorways. Later, as seen in Figures 6 and 7, the owner’s maintenance personnel responded to interior flooding through these poorly crafted thresholds by literally grinding out portions of the outer edge of the metal T-bar flashing and concrete in order to provide drainage relief for areas of particularly troublesome rainwater ponding.

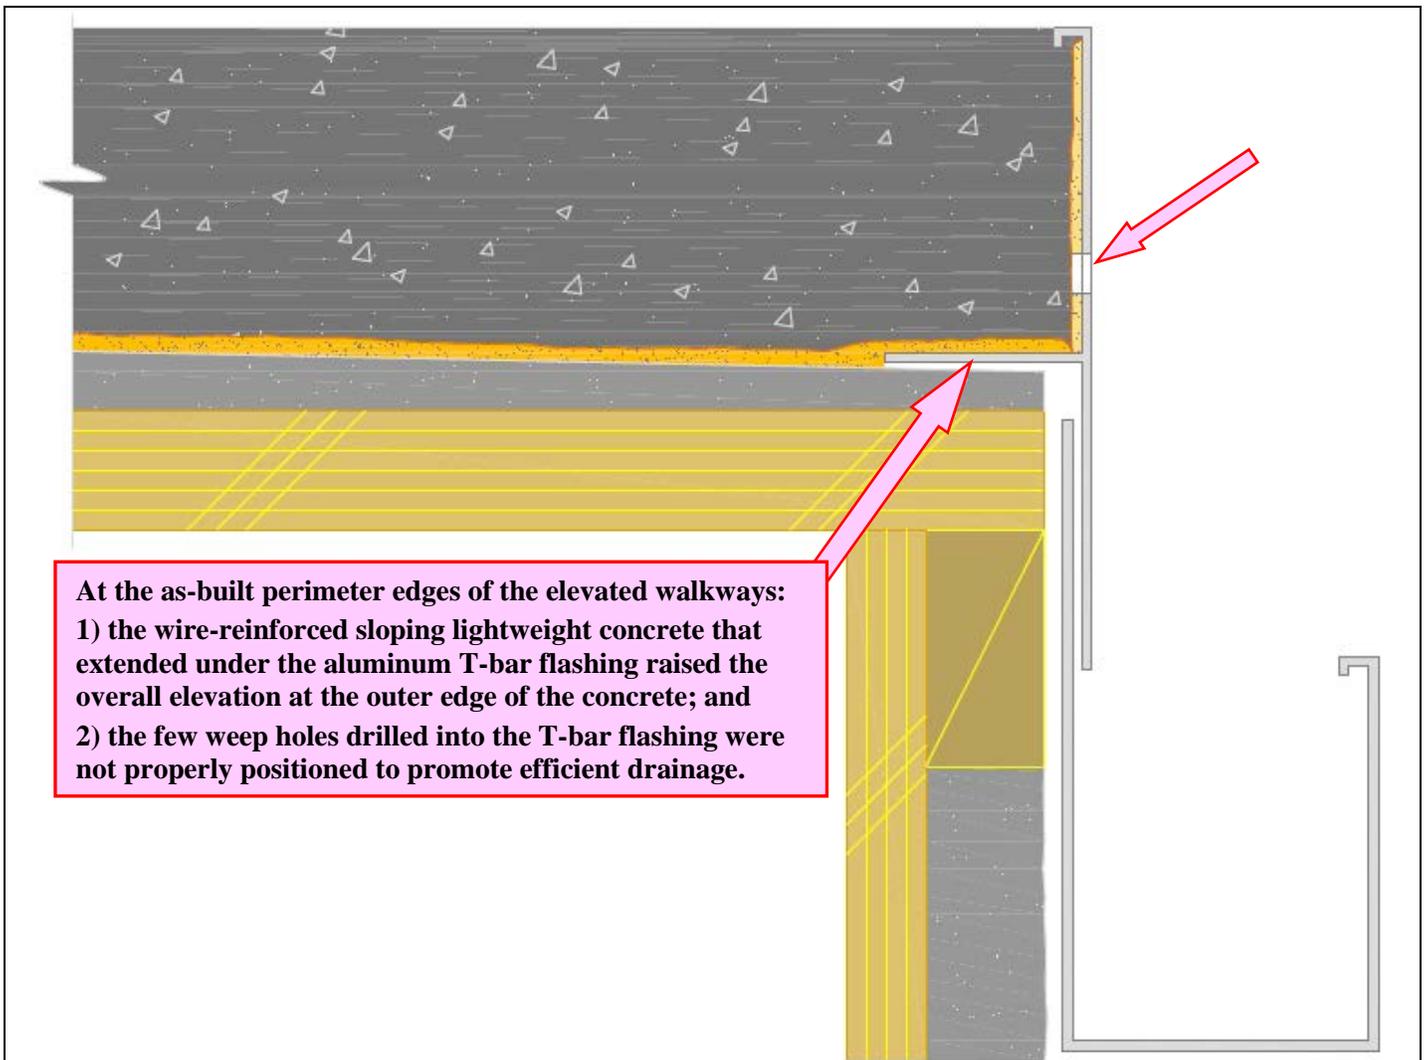
Figure 4 – Sloping lightweight concrete extending under the 2-inch aluminum T-bar flashing at the outer edge served to raise its overall height. Additionally, the relatively few weep holes drilled into this metal flashing were not properly positioned to promote efficient drainage of the waterproofing membrane. (Litigation exhibit by Andrew D. Trias.)

Additionally, note in these two figures (also see Figure 4) that the few weep holes that had been drilled (post construction) into the perimeter aluminum T-bar flashing were not properly positioned to promote efficient drainage of the waterproofing membrane; trapped water eventually leaked down through various as-constructed flashing and membrane deficiencies, attacking the heavy glue-laminated wood structural beams and columns below.

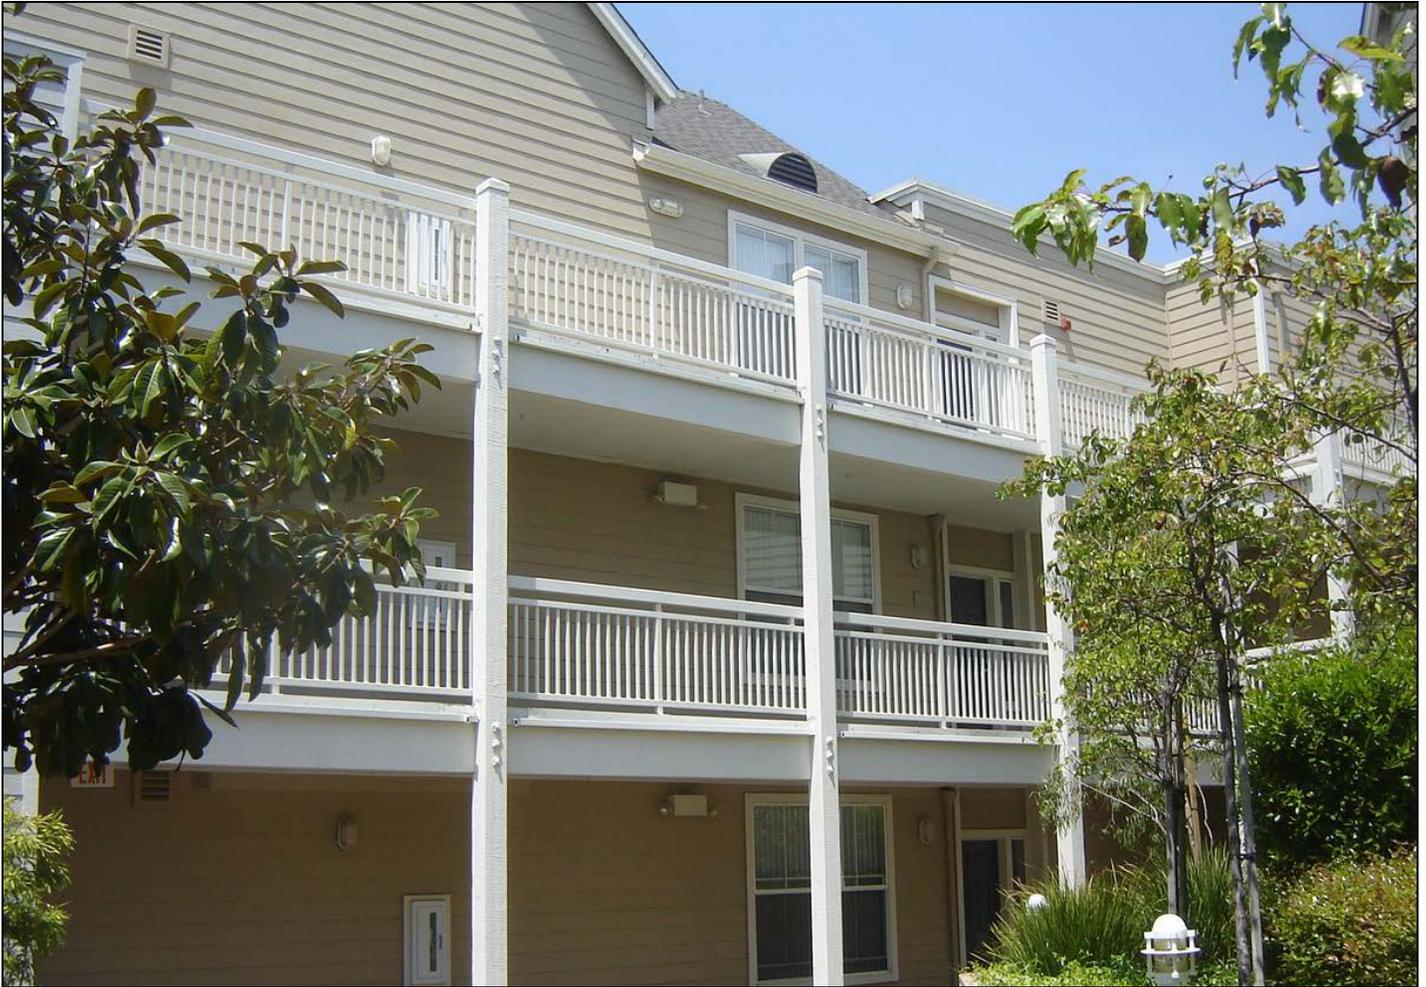
As evidenced by Figures 1 and 5, a complex layout of elevated walkways (totaling 3,000 feet long and 19,200 square feet in area) wrapped around the 104 upper-story units at this facility. Clearly, the architect’s original plan (per Figure 2: providing positive slope for walkway waterproofing drainage by individually cutting a taper into every one of the supporting wood framing members) would have been laborious and costly.

Figure 5 – Elevated walkway posts and beams were manufactured from glue-laminated Alaskan yellow cedar.

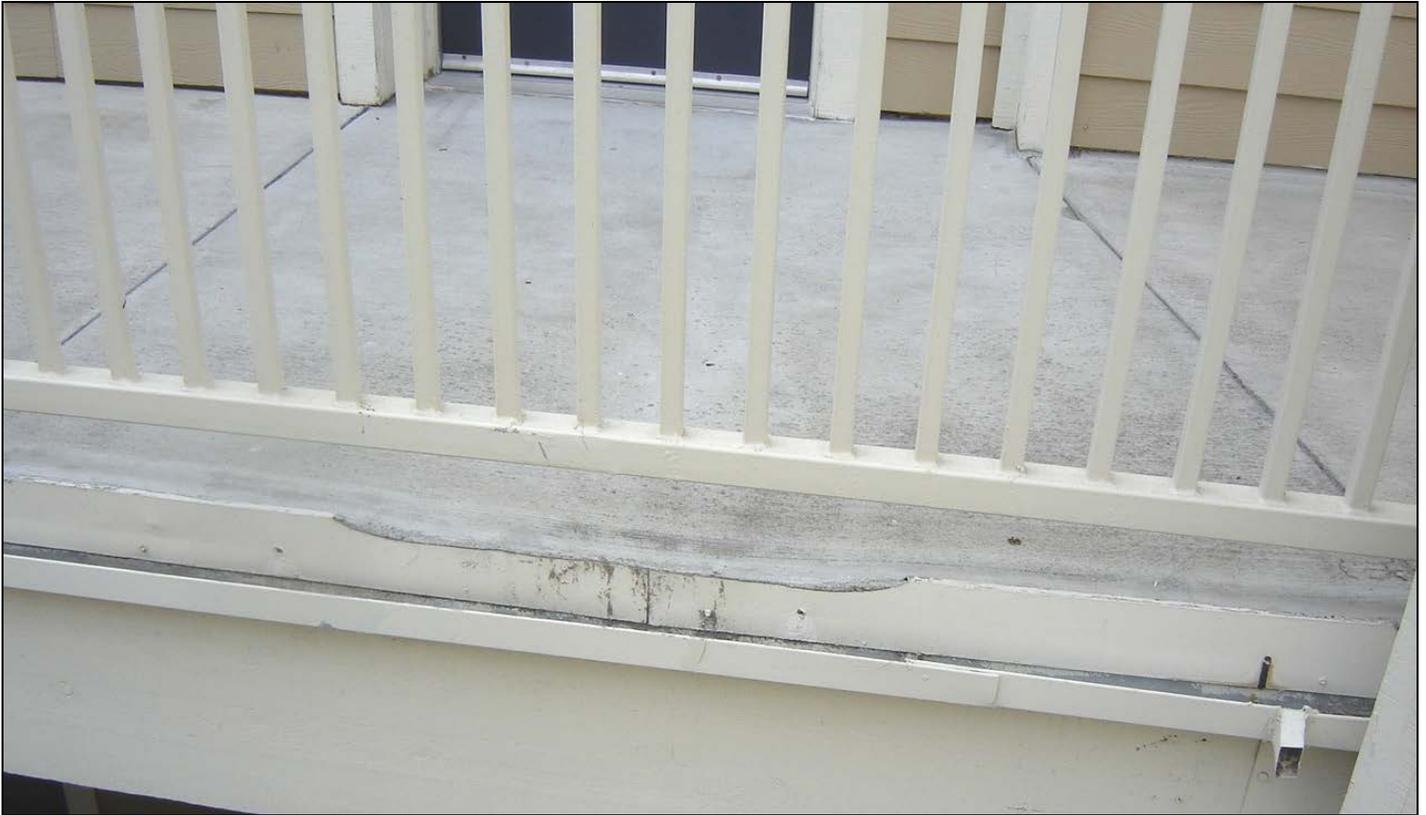
Figure 6 – Maintenance staff had carved out numerous portions of the outer edge of the T-bar flashing and concrete in order to provide drainage relief for areas of particularly problematic ponding.

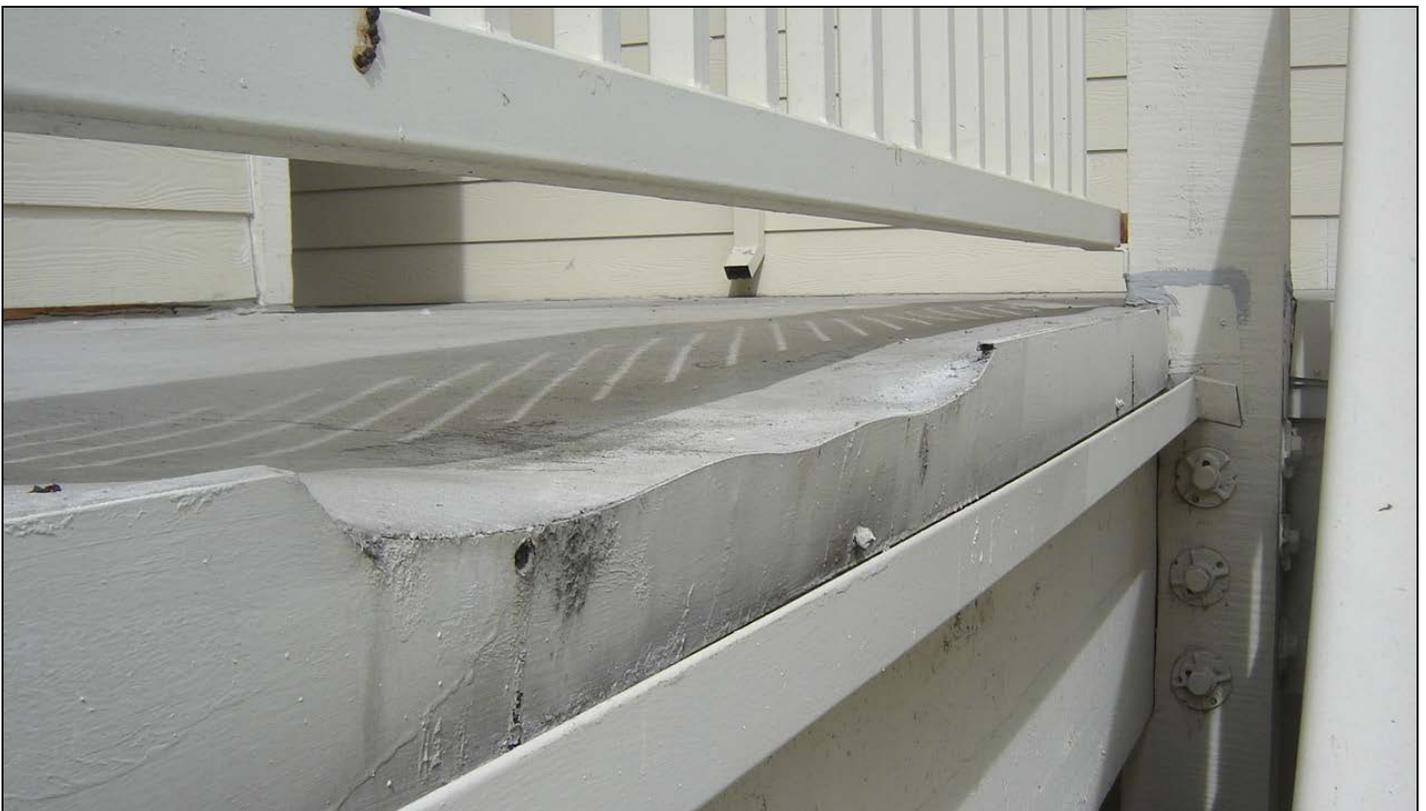
Figure 7 – The relatively few weep holes drilled into the T-bar flashing were not properly positioned (see Figure 4) to promote efficient drainage of the waterproofing membrane.

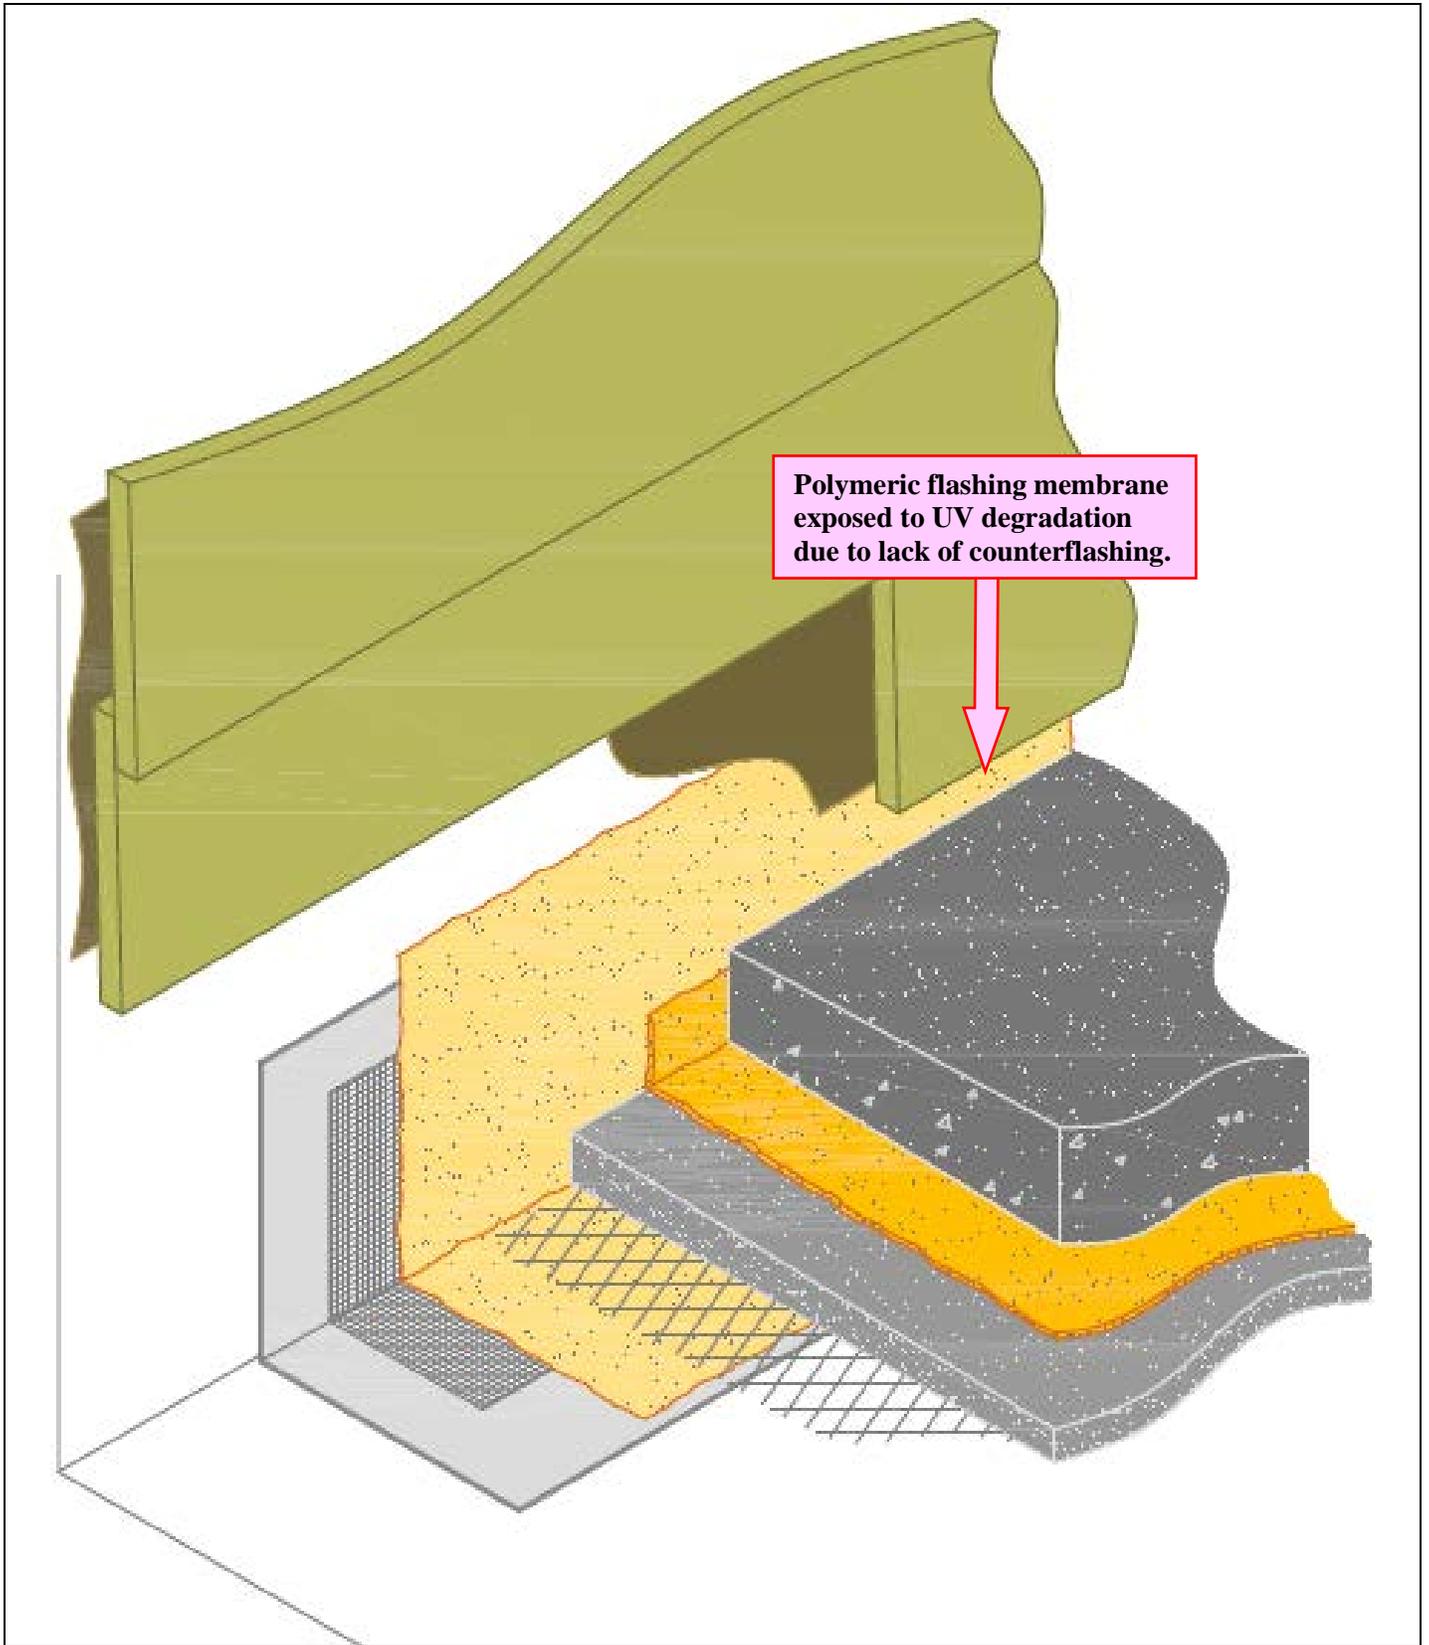
Figure 8 – In lieu of tapered wood framing, the as-built design provided sloping wire-reinforced lightweight concrete under the fluid-applied waterproofing membrane. Additionally, note that UV-resistant counterflashing was not installed to protect the exposed spray-applied flashing membrane from direct sunlight. (Litigation exhibit by Andrew D. Trias.)

As depicted in Figure 8, the polymeric waterproofing membrane was fluid-applied to the top of the lightweight concrete and to the vertical leg of the underlying spray-applied flashing. (Both products had essentially the same two-component synthetic rubber mix.) Unfortunately, even though the architect’s original waterproofing details had shown sheetmetal counterflashing at these walkway-to-wall transitions, none was installed at this gap between the concrete and the fiber-cement lap siding.

Due to this oversight, the spray-applied flashing degraded at multiple locations due to direct exposure to sunlight. As can be seen in Figure 8, any rainwater that infiltrated through voids in the vertical flashing membrane eventually could migrate all the way down to the engineered wood decking below, further exacerbating the deterioration and structural decay found at all of the walkways. (As would be expected, the architect’s failure to notice that his own counterflashing had not been installed was highlighted by several of the parties enmeshed in the ensuing litigation.)
