Variables for Forensic Evaluation of Degradation of Structural OSB Panels Experiencing “Wet” Service

By Colin Murphy, RRC, FRCI, and Lonnie Haughton

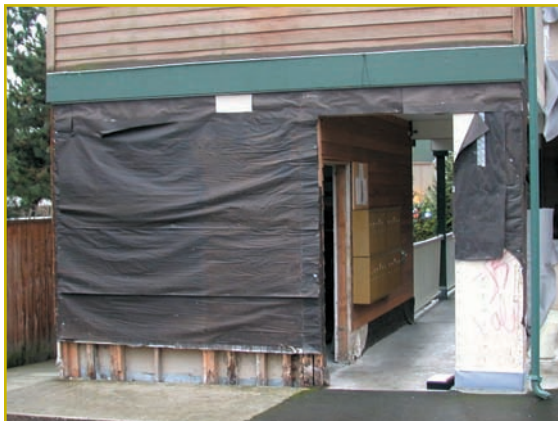
Photo 1 - Overview of the work area.

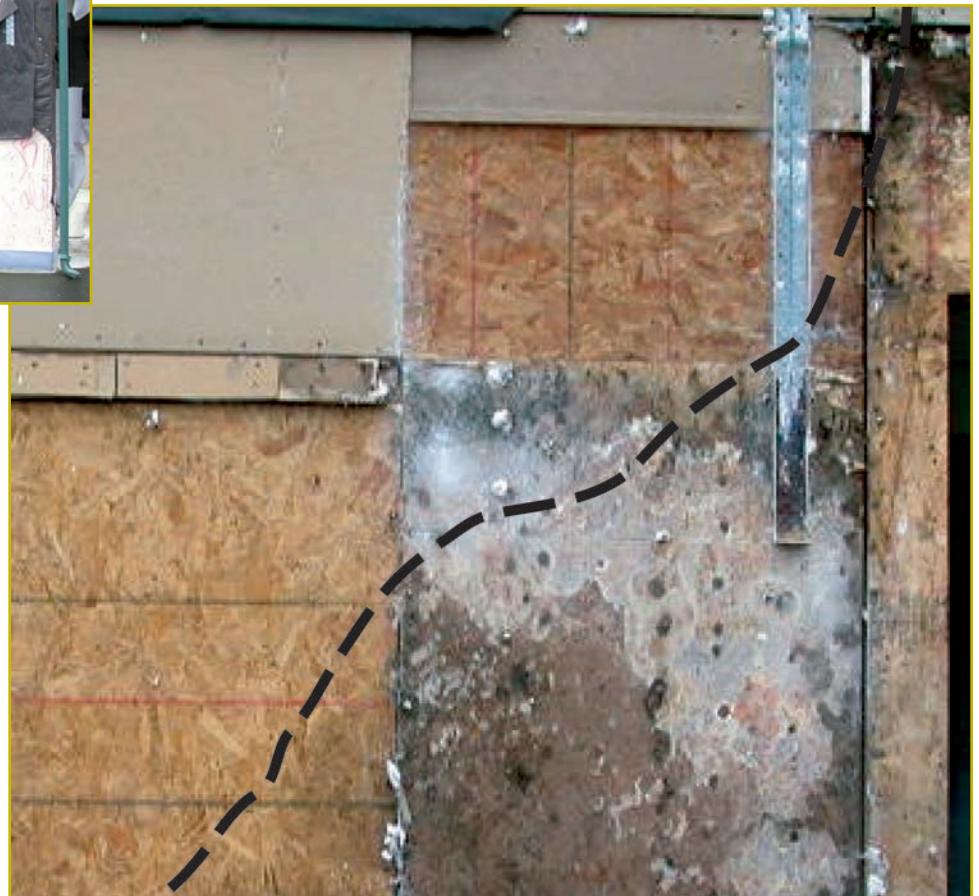
Photo 2 - Hardwood OSB sheathing with severe white-rot decay is surrounded by relatively undamaged hardwood OSB. The dashed line traces the upper limit of the migrating water. Note that the white-rot deterioration has spread upward from the water line. (The localized brown-rot decay at the upper right is spreading from underlying infestation of a softwood-framing member.)

Photo 1 shows an overview of the work area. In *Photo 2*, note the severe white-rot deterioration at one of the sections of hardwood OSB sheathing, while the surrounding hardwood OSB sections are relatively undamaged except for some localized brown-rot damage at the upper right corner. (The observed brown-rot decay has spread from an infested softwood-framing member behind the hardwood sheathing.)

The OSB panels were installed at the same period of construction, as evidenced by the overlying steel strap seen in *Photo 2*. It is possible that the damaged panels had been infected with the white-rot fungi prior to installation, but the almost total absence of white-rot damage at the adjacent OSB sheathing is strong evidence that the OSB panels from Minnesota were highly resistant to this particular wood decay fungus.
