Variables for Forensic Evaluation of Degradation of Structural OSB Panels Experiencing "Wet" Service

By Colin Murphy, RRC, FRCI, and Lonnie Haughton

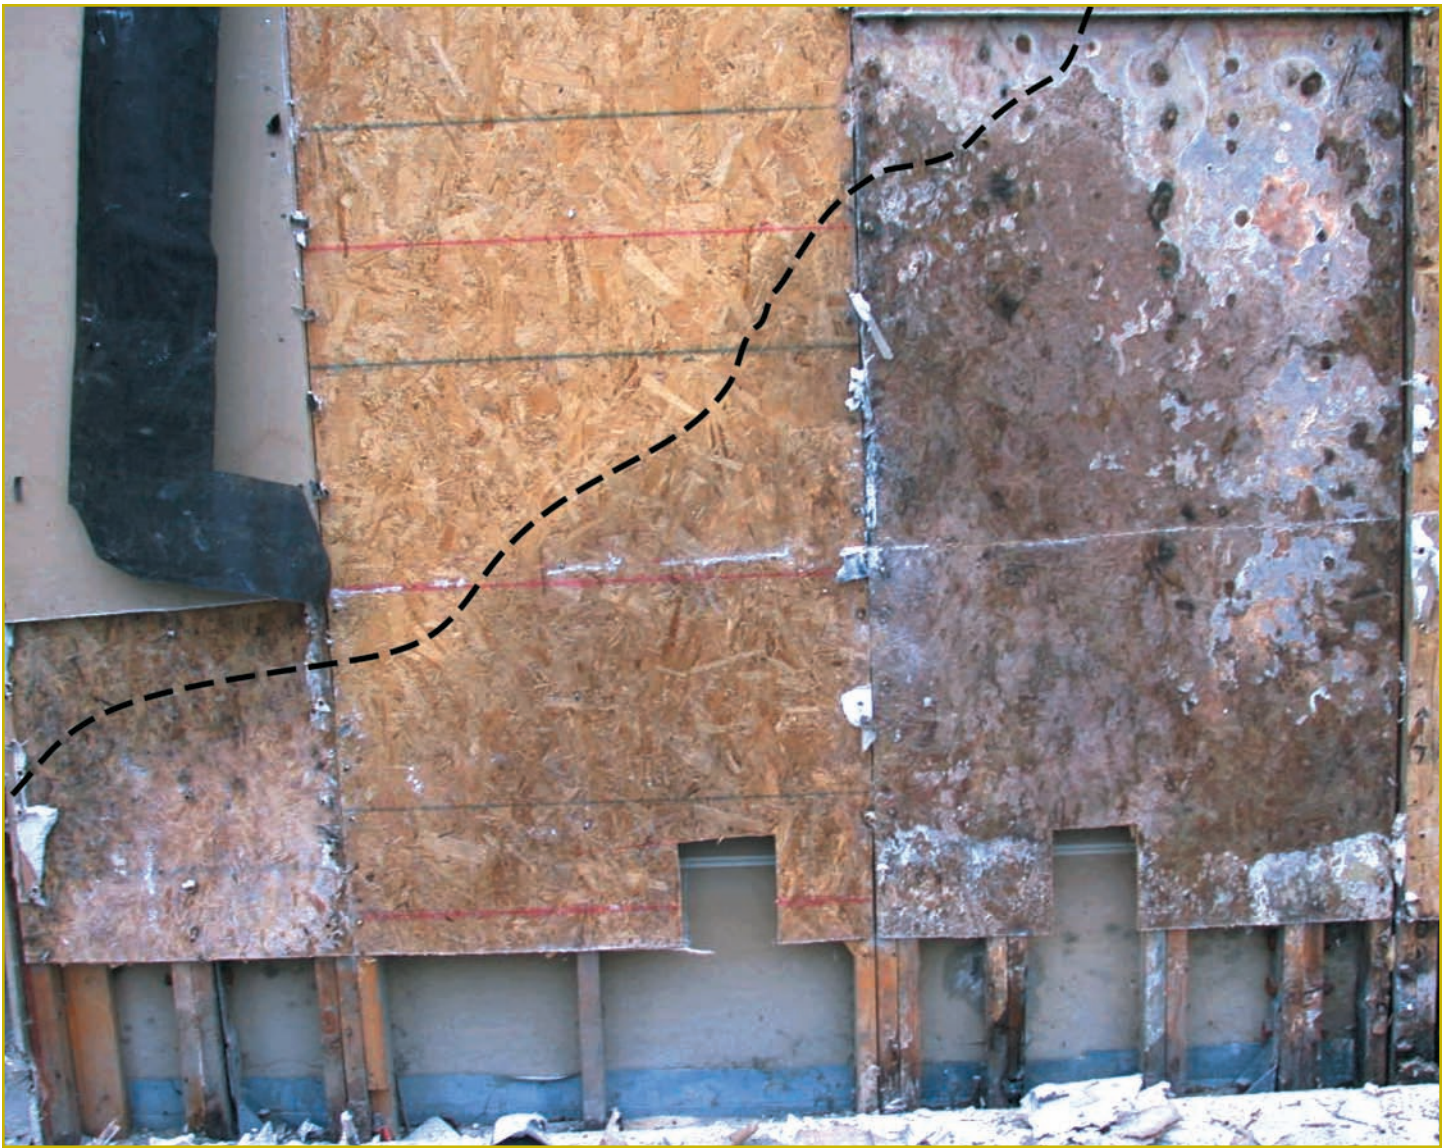
The dramatic differences between the hardwood OSB panels are further highlighted in *Photo 3*. Note the water staining across the face of the otherwise undamaged middle section, tracing the route taken by the migrating moisture that promoted the severe white-rot damage at the OSB section at the right. Further, note that this moisture also has resulted in severe white-rot damage at the OSB section at the far left. Both damaged OSB sections are by the same manufacturer.

The severity of the white-rot deterioration at the left and right sections is advanced. As the panels became saturated and spongy, the fungi were able to spread vertically above the visible path of water flow denoted by the water stain. In striking contrast, the middle OSB section remains sound, firm, and undamaged.

The undamaged OSB sections were the panels manufactured in Minnesota.

Further evaluation at the Forest Products Laboratory, supported by review of online technical publications by the manufacturers, identified two major differences between the two panels: a) the British Columbia panels were found to be comprised of aspen (*populus sp.*) wood strands with an MDI binder; b) the Minnesota panels were comprised of birch (*betula sp.*) wood strands with a phenolic resin binder.

Photo 3 - Undamaged center panel is sandwiched by two white-rotted panels. (The dashed line traces the upper limit of the migrating water.)

Moisture readings with a Delmhorst meter, confirmed by laboratory testing, revealed moisture content levels typically less than 17% (13-15% for the damaged panels and 15-17% for the undamaged panels), indicating no recent conditions of water infiltration to the currently dry sheathing. The lack of viable decay fungi indicated a lengthy period had elapsed since the panels had last been wet. This situation likely was exacerbated by a dearth of appropriate food remaining within the ravaged panels, despite the mass of wood strands available in the adjacent undamaged panels.
