## Flashing 101 – The 1% Rule!

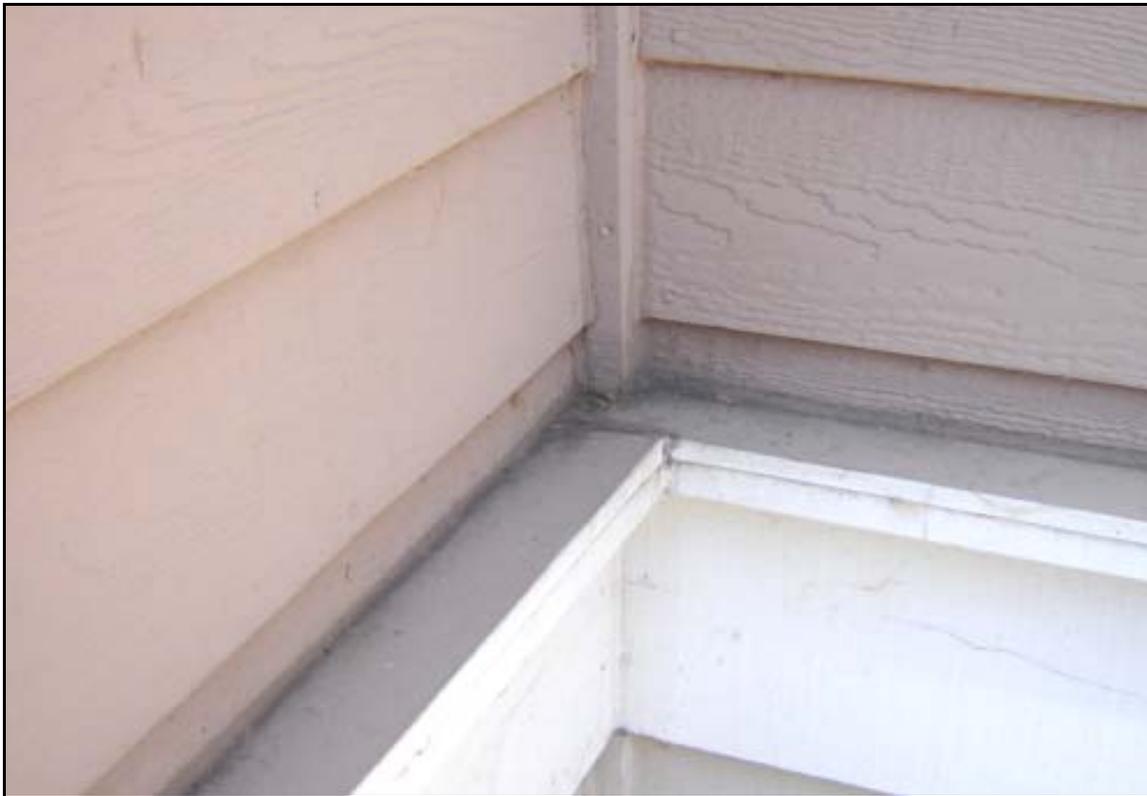
A majority of construction defects litigation cases arise from simple lack of attention to the 1% Rule. Consider the photograph below, which depicts a transition between hardboard lap siding and white-painted wood trimboards that form an aesthetic ‘bellyband’ at the floor line between the 1<sup>st</sup> & 2<sup>nd</sup> stories of this multifamily residential building. Note the metal Z-flashing (also painted white) that was intended to weatherproof this change-in-plane (and change-in-material).

Is this metal Z-flashing ‘installed in such a manner so as to prevent moisture from entering the wall or to redirect it to the exterior’? The answer, of course, is a resounding “No”.

The Z-flashing is sloped toward the building interior, causing water to collect against the water-sensitive hardboard siding, which is improperly installed in direct contact with the metal flashing. Further, the corner overlap joint between the two pieces of Z-metal is not sealed, allowing water infiltration into the wall assembly.

Then, in an unsuccessful attempt to correct this leakage problem, an unknown party later smeared a bead of caulk along the base of the hardboard siding; however, the caulk also blocks the intended exit route for any incidental moisture (from a source located higher up the wall) that may have reached the building paper installed behind the siding. Further, the topical application of caulk at the top of the metal flashing joint quickly failed, allowing continued leakage at the corner.

**Photo 1 – Is this metal flashing installed in such a manner so as to prevent moisture from entering the wall or to redirect it to the exterior?**
