Flashing 101 – The 1% Rule!

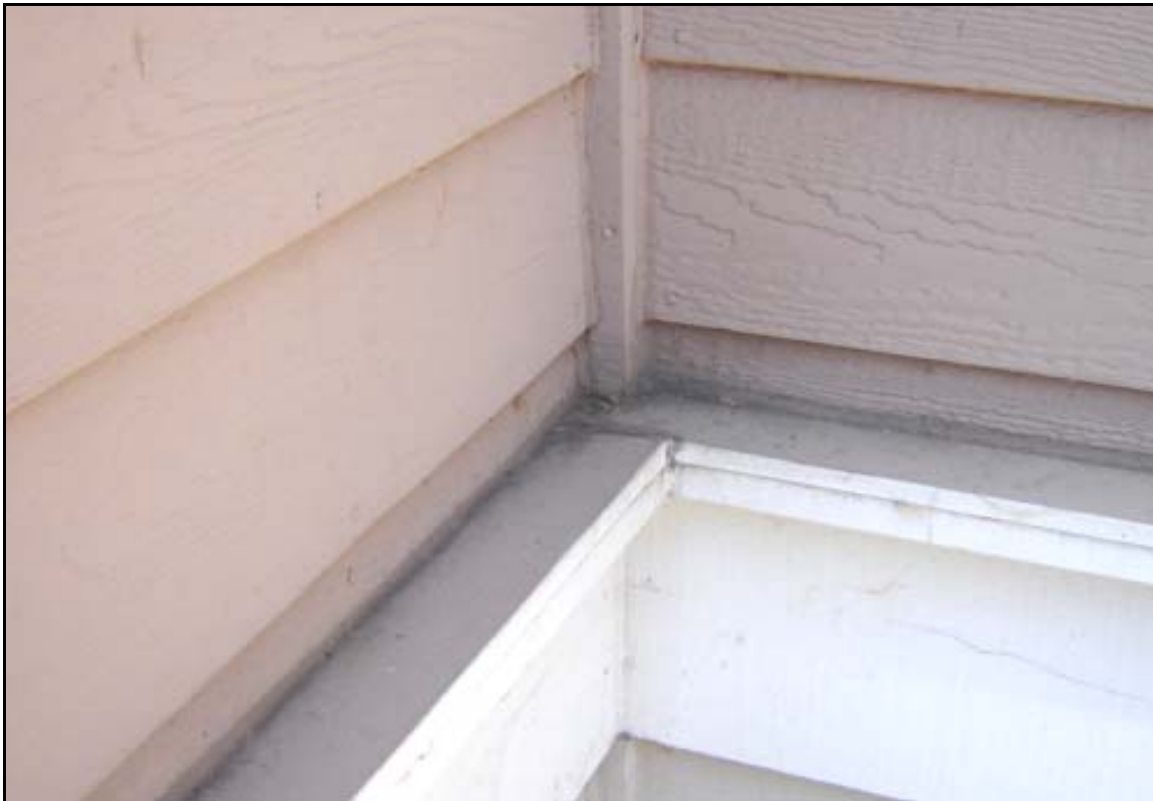
A majority of construction defects litigation cases arise from simple lack of attention to the 1% Rule. Consider the photograph below, which depicts a transition between hardboard lap siding and white-painted wood trimboards that form an aesthetic ‘bellyband’ at the floor line between the 1st & 2nd stories of this multifamily residential building. Note the metal Z-flashing (also painted white) that was intended to weatherproof this change-in-plane (and change-in-material).

Is this metal Z-flashing ‘installed in such a manner so as to prevent moisture from entering the wall or to redirect it to the exterior’? The answer, of course, is a resounding “No”.

The Z-flashing is sloped toward the building interior, causing water to collect against the water-sensitive hardboard siding, which is improperly installed in direct contact with the metal flashing. Further, the corner overlap joint between the two pieces of Z-metal is not sealed, allowing water infiltration into the wall assembly.

Then, in an unsuccessful attempt to correct this leakage problem, an unknown party later smeared a bead of caulk along the base of the hardboard siding; however, the caulk also blocks the intended exit route for any incidental moisture (from a source located higher up the wall) that may have reached the building paper installed behind the siding. Further, the topical application of caulk at the top of the metal flashing joint quickly failed, allowing continued leakage at the corner.

Photo 1 – Is this metal flashing installed in such a manner so as to prevent moisture from entering the wall or to redirect it to the exterior?
