## The 4 D's of Building Envelope Design

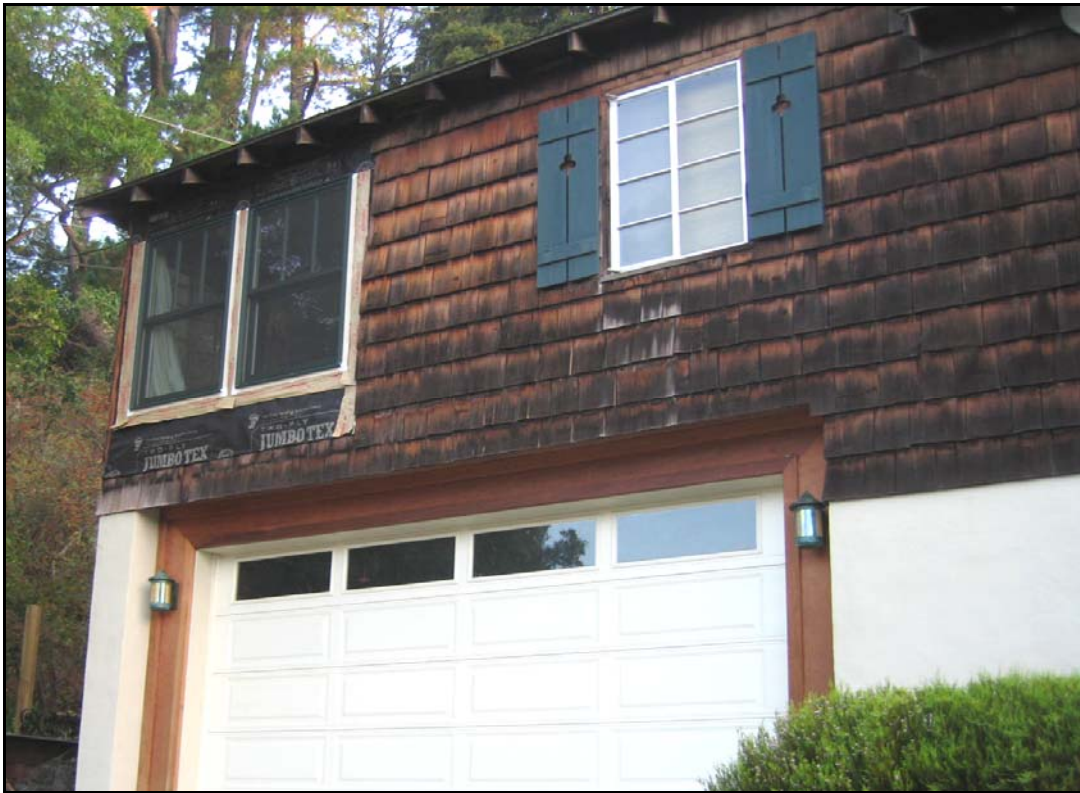
**Photo 1 – Owner Is Replacing the Original Aluminum Windows (at Right) with New Metal-Clad Wood Windows (at Left). Note the Severely Deteriorated Redwood Shakes**

In Photo 1, we see that the owner is replacing the original small single-paned aluminum casement windows with larger double-paned double-hung Marvin windows. Note the severe deterioration of the original old-growth redwood shakes, which required total replacement at this weather-exposed elevation. It also is important to note that while the redwood shakes had been attached to one layer of 30# felt, no effort had been made to flash the original aluminum windows.

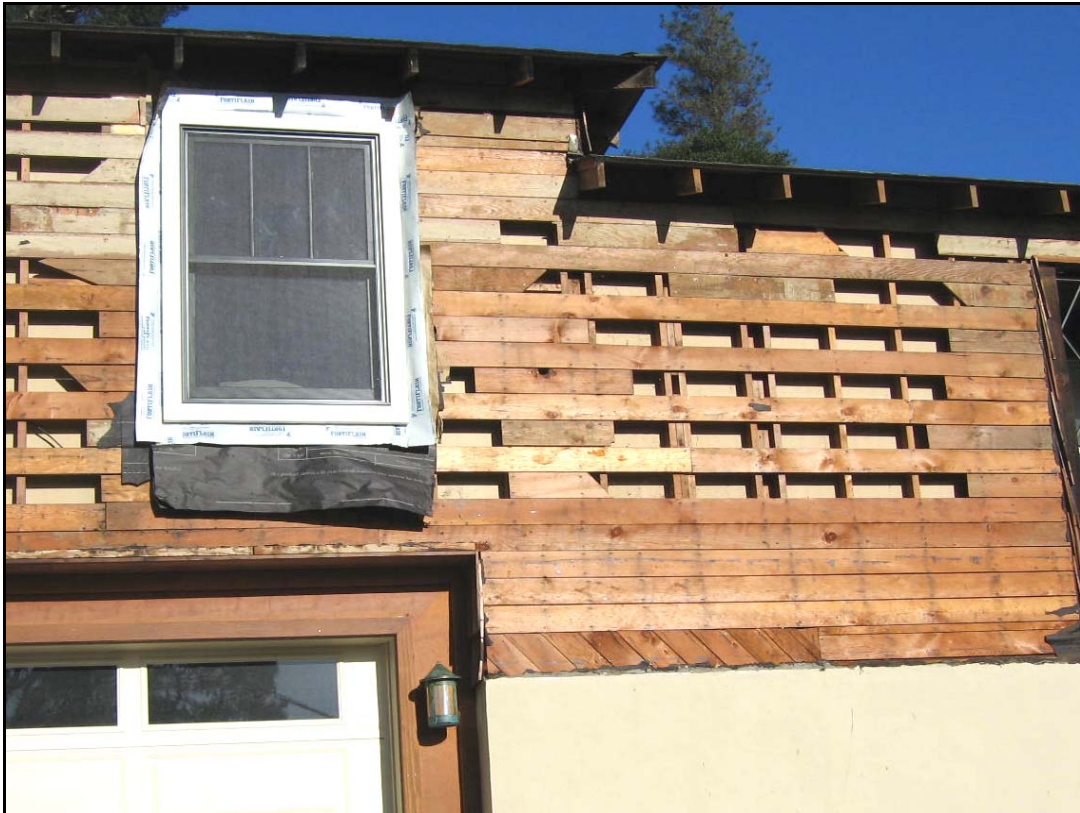
**Photo 2 – However, Removal of the Deteriorated Redwood Shakes Reveals No Water Damage at the Wood Board Sheathing or Stud Framing**

However, in Photo 2 we see that despite the extensive decay of the redwood shakes, there is absolutely no water damage at the wood sheathing or framing. To understand this phenomenon, we need to consider the 4 D's of the original wall design:

- **Deflection** – the relatively small roof overhang provided only a FAIR degree of rainfall deflection.
- **Drainage** – the failure to install a gutter at the roof and the lack of any flashing at the original windows represents POOR drainage performance.

- **Drying** – the exterior wall has no insulation, no interior vapor retarder and numerous open spaces between the wood sheathing boards. As a result, the design provides EXCELLENT drying performance from both the interior (during wet winter months) and the exterior (during the dry summer season).

- **Durability** – the old-growth redwood shakes exhibited GOOD durability, as evidenced by their overall survival for more than 50 years in a wet climate below a gutter-less roof. In addition, the heavily built window frames, which were manufactured in the post-World War II era when aluminum was plentiful and cheap, continued to provide exceptional durability.

In short, despite poor *drainage* and only fair *deflection* properties, this energy-inefficient wall assembly provided more than 50 years of complete weather-resistive performance due primarily to continual *drying* at the back side of the durable redwood shakes that covered the wall.
